Contract #: 04-0120F4Cty: SF/ALA Rte: 80 PM: 13.2/13.9File #: 99.28**WELDING INSPECTION REPORT****Resident Engineer:**Siegenthaler, Peter**Address:** 333 Burma Road**City:** Oakland, CA 94607**Report No:** WIR-020073**Date Inspected:** 29-Jan-2011**Project Name:** SAS Superstructure**OSM Arrival Time:** 700**Prime Contractor:** American Bridge/Fluor Enterprises, a JV**OSM Departure Time:** 1900**Contractor:** Zhenhua Port Machinery Company, Ltd (ZPMC) Chanxing Island**Location:** Shanghai, China**CWI Name:** Mr. Qui Wen**CWI Present:** Yes No**Inspected CWI report:** Yes No N/A**Rod Oven in Use:** Yes No N/A**Electrode to specification:** Yes No N/A**Weld Procedures Followed:** Yes No N/A**Qualified Welders:** Yes No N/A**Verified Joint Fit-up:** Yes No N/A**Approved Drawings:** Yes No N/A**Approved WPS:** Yes No N/A**Delayed / Cancelled:** Yes No N/A**Bridge No:** 34-0006**Component:** OBG Segment**Summary of Items Observed:**

WELDING INSPECTION REPORT

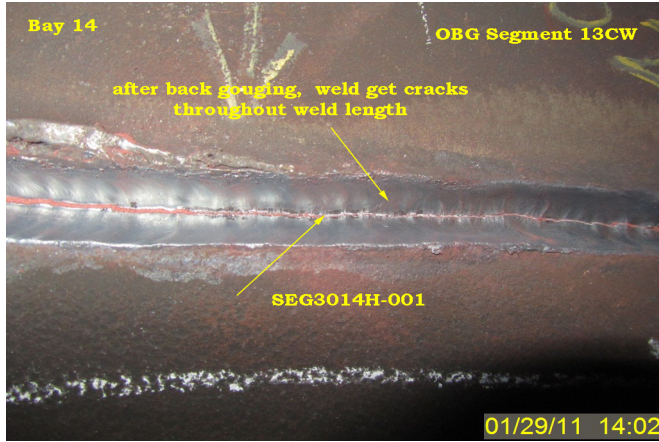
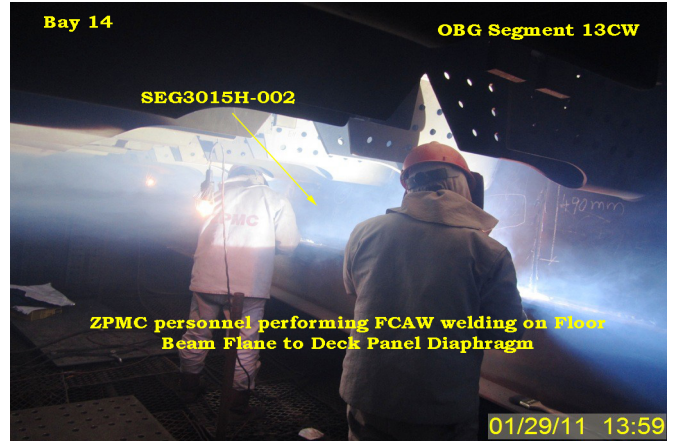
Description of Incident: During the Quality Assurance random visual inspection of welds located on Segment 13CW, this Quality Assurance Inspector (QA) observed that ZMPC personnel performed welding on Deck Panel Diaphragm to deck panel diaphragm weld, after back gouging of these welds are get cracks throughout weld length at cross beam side of OBG Segment 13CW. This weld is a Complete Joint Penetration (CJP) weld joining the Deck Panel Diaphragm to deck panel diaphragm weld. The Deck Panel Diaphragm to deck panel diaphragm weld is identified as Seismic Performance Critical Member (SPCM. The weld numbers are identified as SEG3014H-001. OBG segment 13CW is located West Side of Bay 14 area. The ZPMC QC is identified as Mr. Sun Tian Liang. QA inform to ZPMC that prior to the repair welding, to prepare CWR and ensure with VT and MT all defect have been removed. See the attaché picture.
